OLYPHANT NO. 3 DAM  
NDI ID NO. PA-00381  
DER ID NO. 35-03

PENNSYLVANIA GAS AND WATER COMPANY

PHASE I INSPECTION REPORT  
NATIONAL DAM INSPECTION PROGRAM

JANUARY 1979

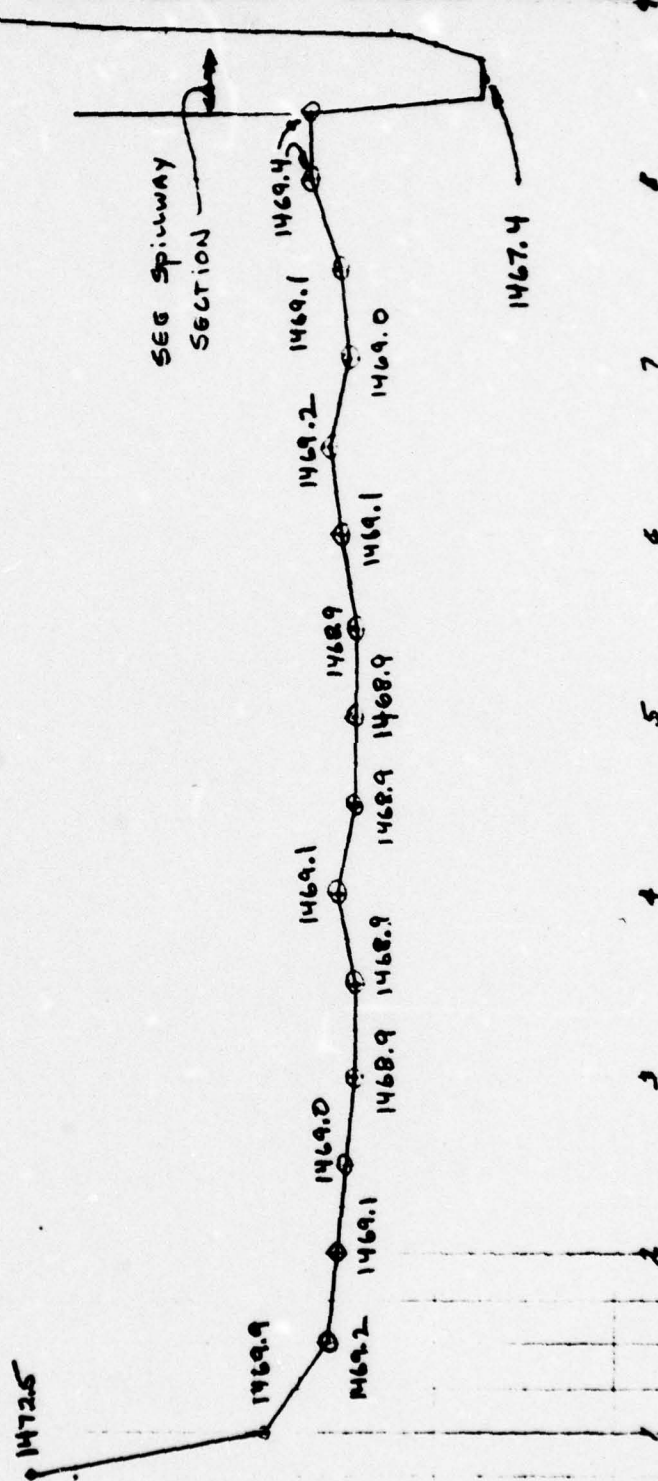
PROFILE  
LOOKING DOWNSTREAM  
SCALE:  
VERT. 1" = 2'  
HORIZ. 1" = 100'

(2) Embankment. If the dam were overtopped, the riprap on the downstream face of the embankment would cause a slightly longer time of failure than a similar unprotected slope. The low areas on the top of the dam reduce the spillway discharge capacity.
